Use of CT in Detection of Internal Damage and Repair and Determination of Authenticity in High-Quality Bowed Stringed Instruments¹

Steven A. Sirr, MD

John R. Waddle, Luthier

RadioGraphics 1999; 19:639-646

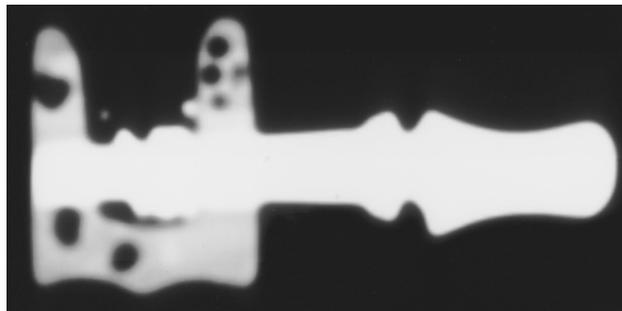
3.

Figures 3, 4. (3) High-resolution transaxial CT scan of a valuable violin reveals a network of wormholes in the peg box. The high-attenuation structure is an ebony peg. (4) High-resolution transaxial CT scan of a Venetian cello demonstrates a network of wormholes (arrow) in the scroll. A small amount of glue is seen at the edge of the scroll (arrowhead).

Varying degrees of damage or repair were detected in all 17 instruments. CT demonstrated damage from worm infestation in two violins and one cello (Figs 3, 4). An air gap between the rib and an internal corner block was detected in a Stradivarius violin (Fig 5). Plastic de-

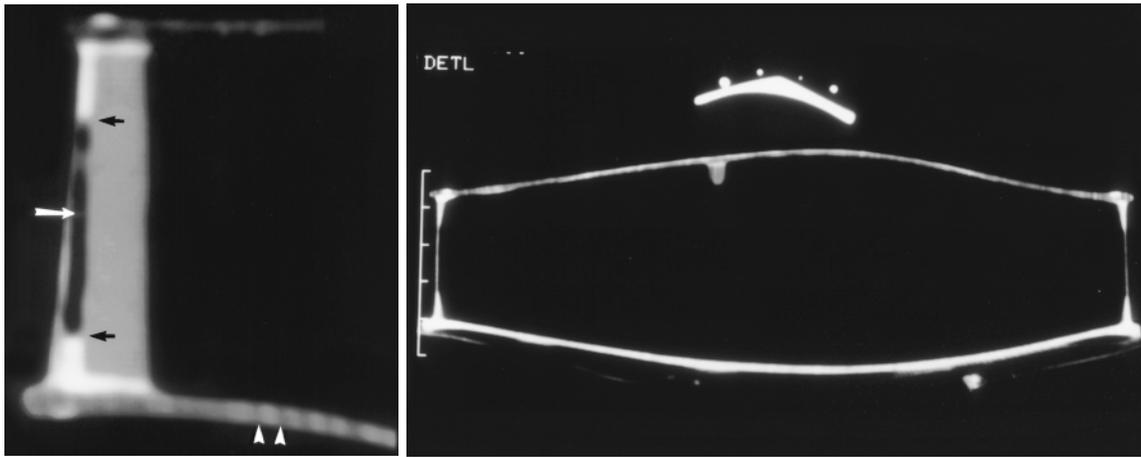
5. 6.
Figures 5, 6. (5) High-resolution transaxial CT scan of a Stradivarius violin shows an air gap (white arrow) between the rib and an internal corner block. Note the two air-glue interfaces between the inner surface of the rib and the inner corner block (black arrows). Arrowheads indicate the back plate. (6) High-resolution transaxial CT scan of the front plate of a very old and valuable Stradivarius violin shows mild, asymmetric plastic deformity of the front plate and tilting deformity of the ebony fingerboard.

formity of wood was detected in five instruments. Figure 6 illustrates deformity of the spruce front plate and ebony fingerboard of a Stradivarius violin.

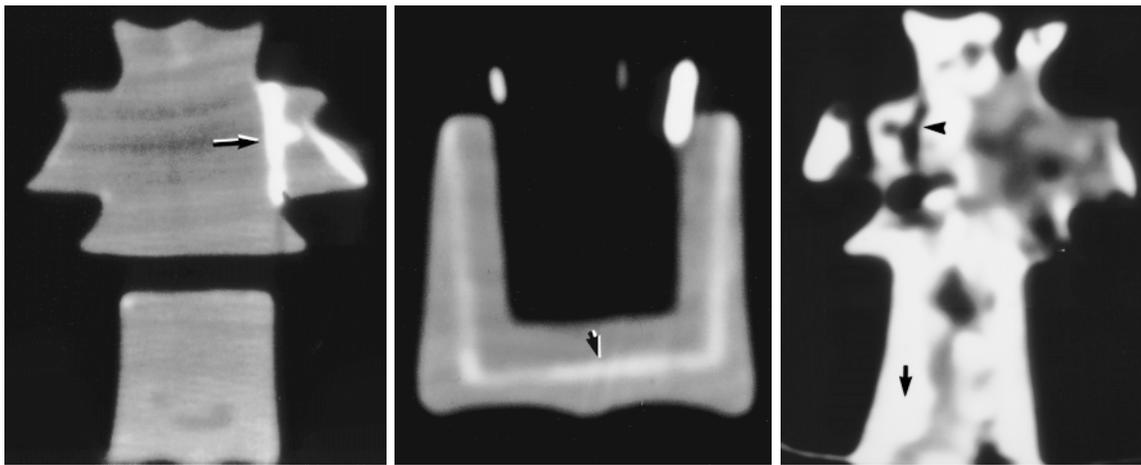
7. 8. 9.
Figures 7–9. (7) High-resolution transaxial CT scan of the scroll of an old and valuable Italian violin shows a linear region of high attenuation (arrow), consistent with glue repair. (8) High-resolution transaxial CT scan of the peg box of a valuable violin shows a linear area of high attenuation that represents glue repair (arrow). (9) High-resolution transaxial CT scan of the scroll of an old Italian violin demonstrates wormholes (arrowhead) and high-attenuation filler material (arrow) occupying a large volume of the scroll. Multiple wormholes several millimeters in diameter were visible on the surface of the scroll. An expert luthier had painted a wood grain pattern on the surface to conceal the filler material.

Cracks repaired with animal glue were detected in all instruments (Figs 7, 8). High-attenuation filler material nearly completely replaced the scroll in one Italian violin (Fig 9).

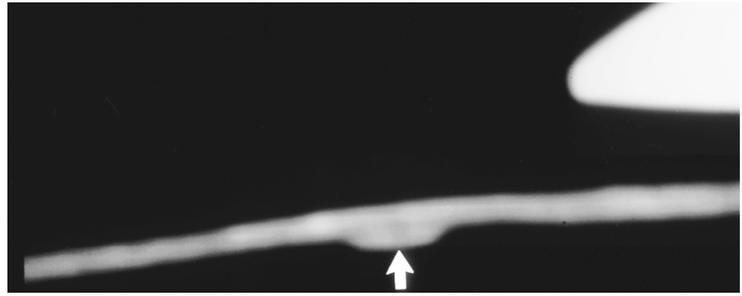
10a.

Figures 10, 11. (10a) High-resolution transaxial CT scan of a Stradivarius violin shows a wooden cleat (arrow) glued to the inside surface of the front plate. (10b) High-resolution coronal CT scan of the front plate shows multiple wooden cleats (arrowheads) and the large, round wooden patch (open straight arrow), which involves almost the entire middle bout of the violin. Note the relationship between the *f*-holes, the bass bar (solid curved arrow), the sound post (solid straight arrow), and the foot of the bridge distal to the sound post (open curved arrow). (11) High-resolution transaxial CT scan of the front plate of a high-quality Venetian cello shows the typical appearance of an internal wooden patch (bracket) and its interface with the original front plate (arrows). Note the discontinuity between the grain pattern of the original front plate and that of the embedded wooden patch. This patch occupied nearly 50% of the thickness of the original front plate.

In addition, wooden patches or cleats were detected in all instruments. Figure 10 shows the transaxial and coronal CT appearance of cleats in a Stradivarius violin. The characteristic CT appearance of discontinuity between the

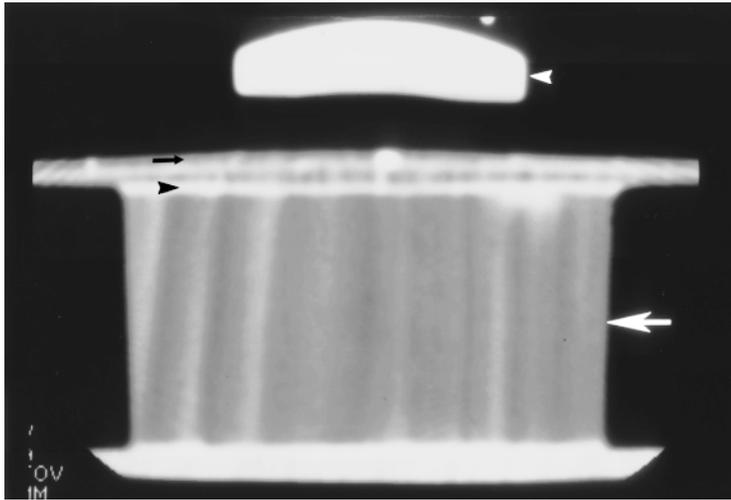
grain lines of the original wood and those of an internal wooden patch embedded in the front plate of a Venetian cello is shown in Figure 11. Figure 12 demonstrates an internal wooden patch embedded in the front plate of a violin. The internal wood grain patterns in the scrolls of a Stradivarius violin and a Venetian cello are shown in Figure 13.

Figure 12. High-resolution transaxial CT scan of a violin demonstrates an internal wooden patch (black arrowhead) positioned between an internal block (white arrow) and the front plate (black arrow). Note the discontinuity between the grain pattern of the newer wooden patch and that of the original front plate. The ebony fingerboard (white arrowhead) has high attenuation.
