Use of CT in Detection of Internal Damage and Repair and Determination of Authenticity in High-Quality Bowed Stringed Instruments¹

Steven A. Sirr, MD

John R. Waddle, Luthier

RadioGraphics 1999; 19:639-646

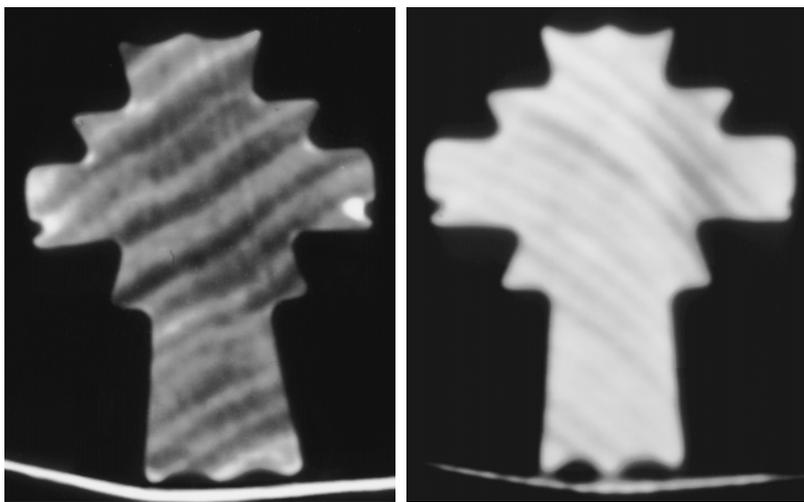
grain lines of the original wood and those of an internal wooden patch embedded in the front plate of a Venetian cello is shown in Figure 11. Figure 12 demonstrates an internal wooden patch embedded in the front plate of a violin. The internal wood grain patterns in the scrolls of a Stradivarius violin and a Venetian cello are shown in Figure 13.

Figure 12. High-resolution transaxial CT scan of a violin demonstrates an internal wooden patch (black arrowhead) positioned between an internal block (white arrow) and the front plate (black arrow). Note the discontinuity between the grain pattern of the newer wooden patch and that of the original front plate. The ebony fingerboard (white arrowhead) has high attenuation.
